When replying, please refer to:  
**OTTER POND DAM, DAMID 410208**  
**Water Division 4, Water District 41**

**SUBJECT: Engineer's Inspection Report**

## ENGINEER'S INSPECTION REPORT

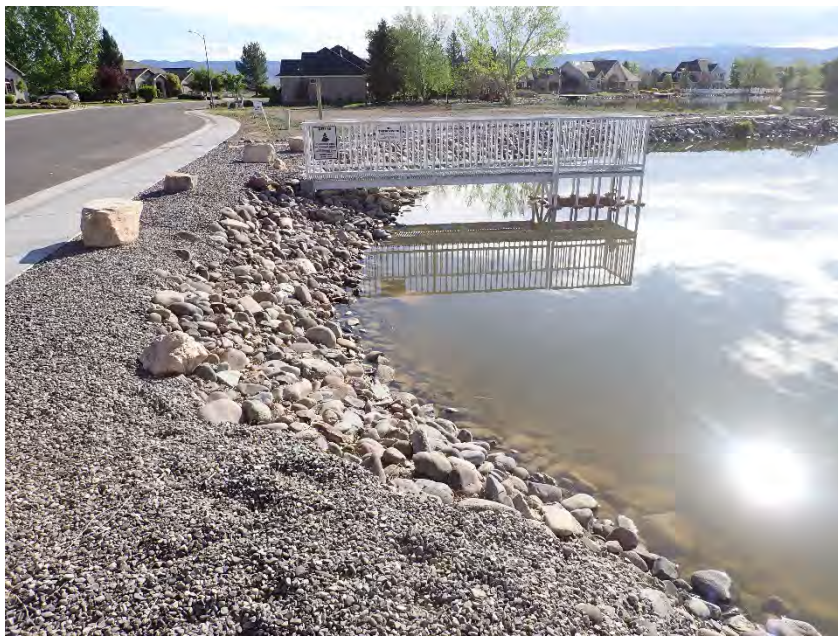
Full riprap coverage to dam crest. Riprap and slope have new as-constructed appearance following recent completion of SEO Construction No. C-2135. No problems observed.

View along upstream slope from left abutment.

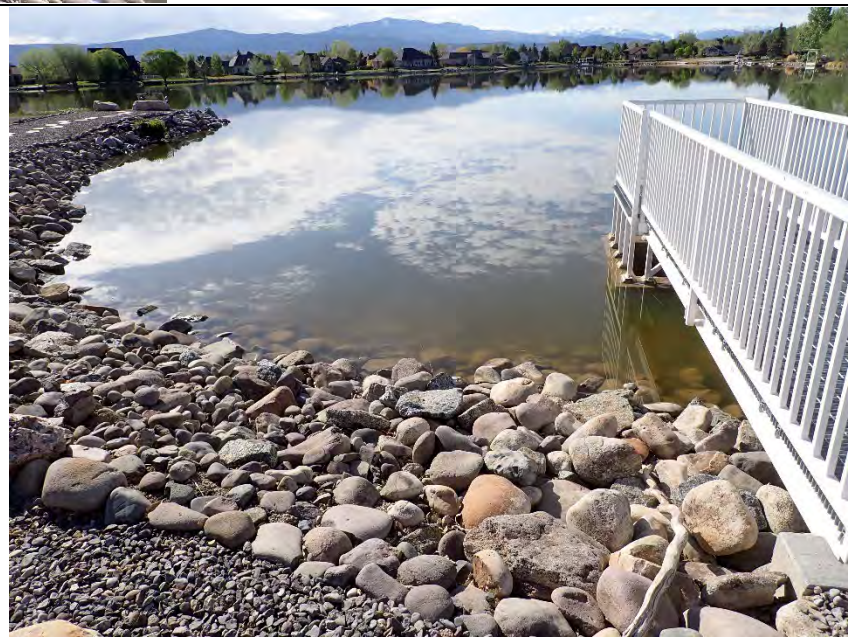
Upstream slope and right side of outlet gate access walkway.

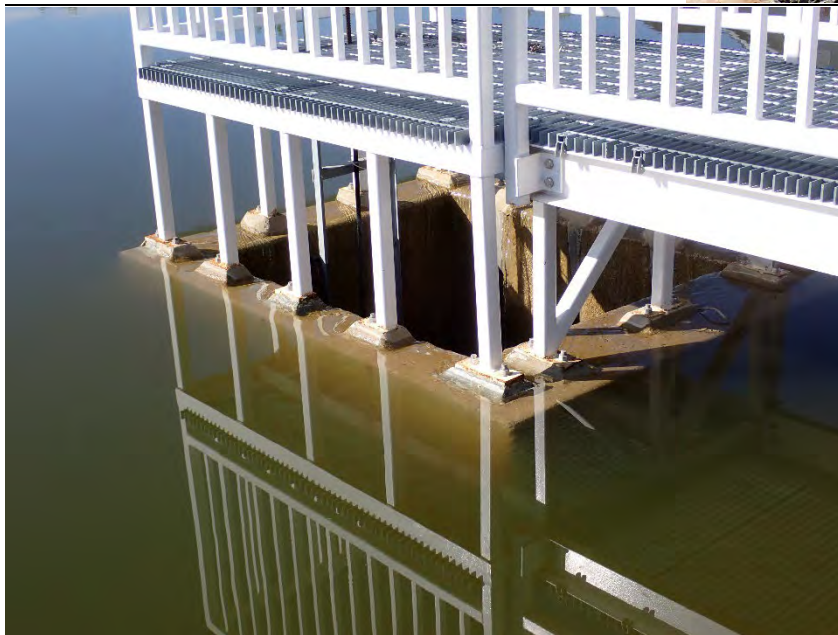
Combined overflow drop spillway with outlet works approved and constructed under SEO Construction No. C-2135. Spillway flowing during inspection. Uniform conditions around square intake with no problems observed.

Right side of trashrack bars and combined service/emergency spillway drop structure.

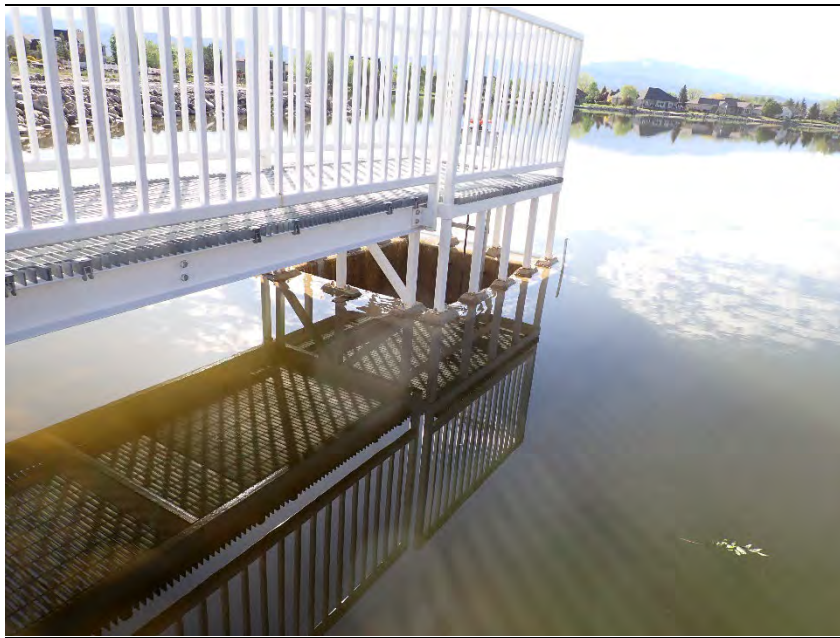
Left side of trashrack bars and combined service/emergency spillway drop structure.

Note reservoir staff gage reading of approximately 9.25-feet during inspection (which matches as-constructed drawing with spillway at gage height 9.1-feet and approximately 0.15-feet depth flowing over crest during inspection).

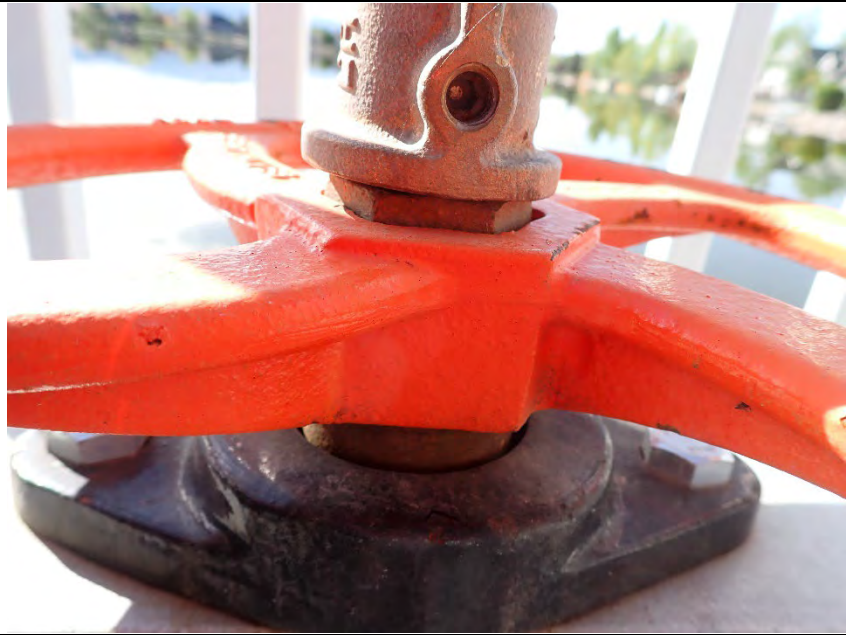
Stop nut flush with gate stem at full closure appears correctly set.

☐ LUBRICATE AND OPERATE OUTLET GATES THROUGH FULL CYCLE

5/9/2025 - At least once every other year at the safety inspection.

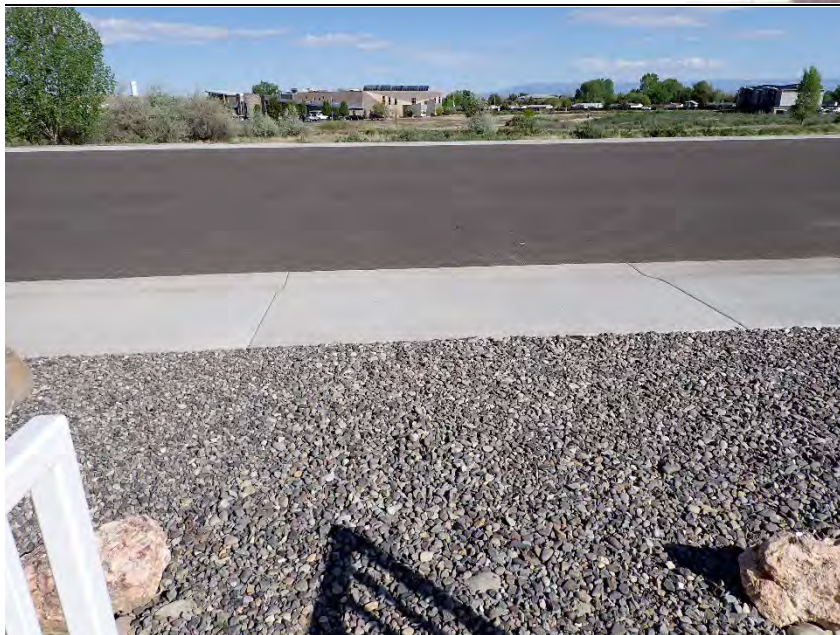
Paved crest has new as-constructed appearance following recent completion of SEO Construction No. C-2135. No problems observed.

View across paved dam crest from walkway.

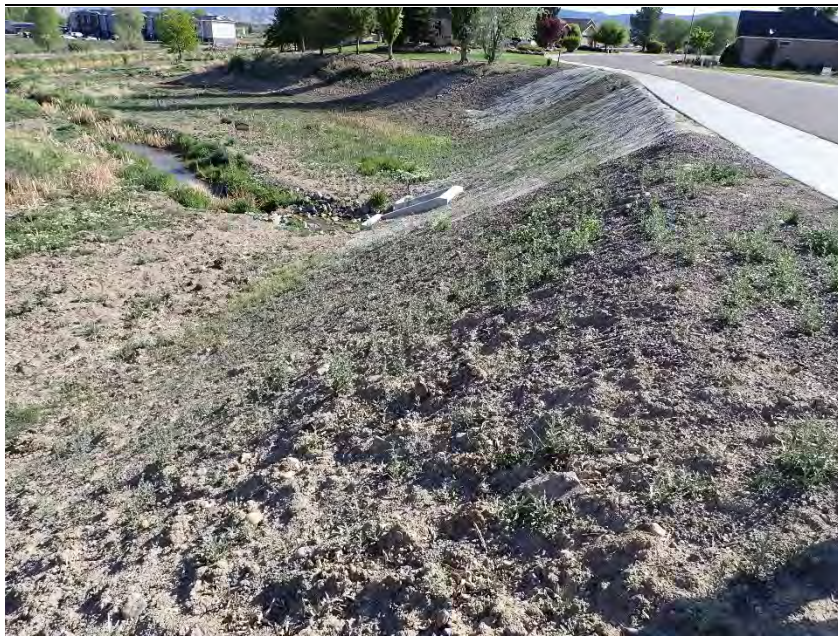
Downstream slope has new as-constructed appearance following recent completion of SEO Construction No. C-2135. No problems observed.

Downstream slope from left abutment.

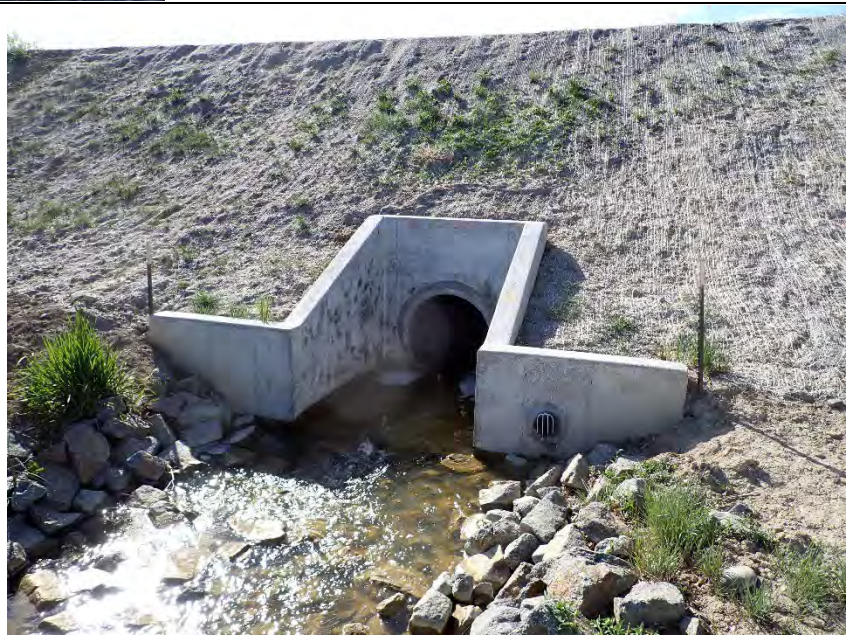
Downstream outlet structure.

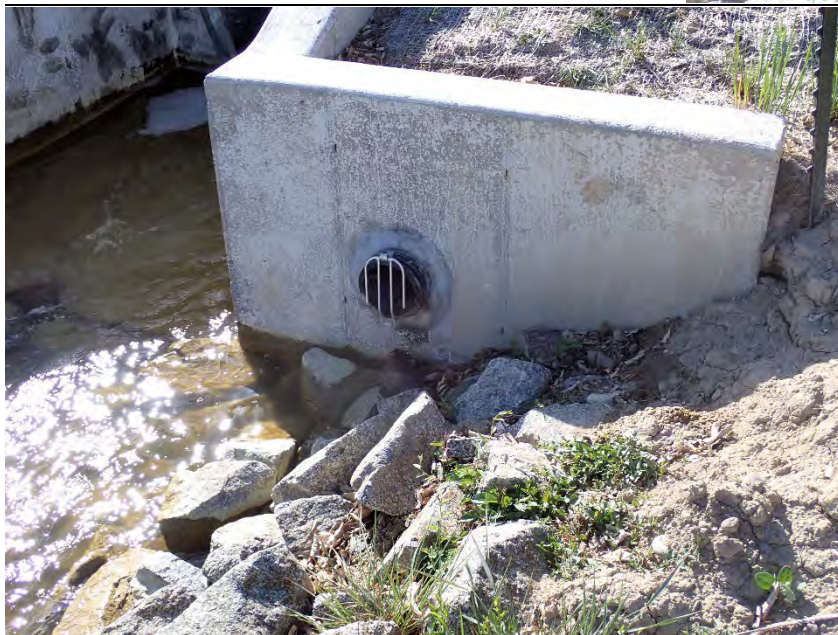
Steady drip from filter collar drain outfall.

Close-up of filter collar drain outfall. Slow drip flow observed during inspection.

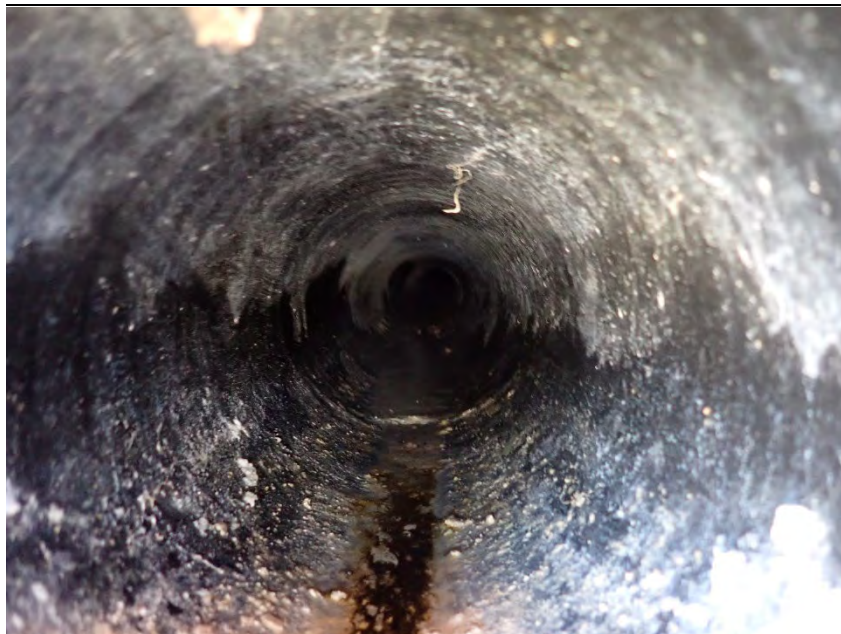
Internal view of filter collar drain outfall.

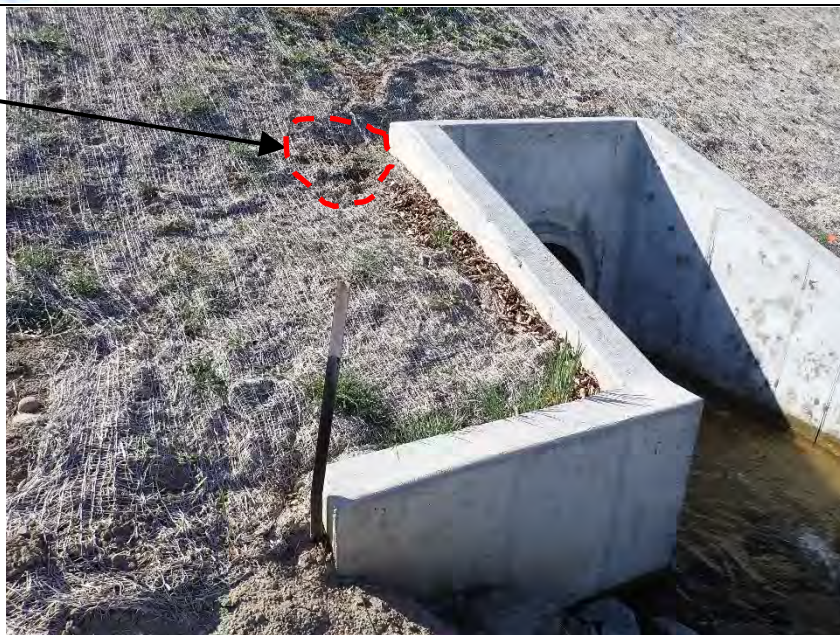
Damp ground area approximately 18-inches in diameter adjacent to top right edge of downstream outlet structure. Uncertain if seepage related, but surrounding soil appeared dry. Area is damp with no signs of flowing water or saturated conditions.

Localize area of damp ground  
(not saturated and no flow)

Right side of downstream outlet structure.

5/9/2025 - Visually monitor damp area adjacent to upper right corner of outlet structure for changes.

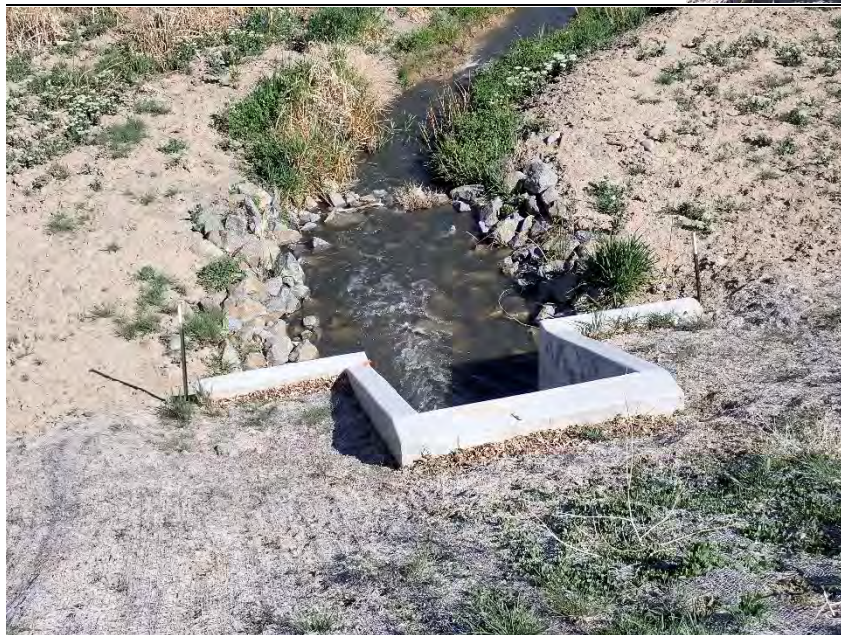
Outlet gate closed during inspection, but (45) operated at end of inspection with no problems observed. Gate appeared to fully close after exercised, but unable to fully evaluate due to combined spillway flow. All exposed outlet components appear in new as-constructed condition.

Outlet flowing during gate exercise. Note discolored water.
